Mining to Modern Landfill

GRP Ltd C&D Landfill

Luke Matheson and Dawn Mercado | Pattle Delamore Partners Ltd

Case study of mine site remediation and land reuse as landfill

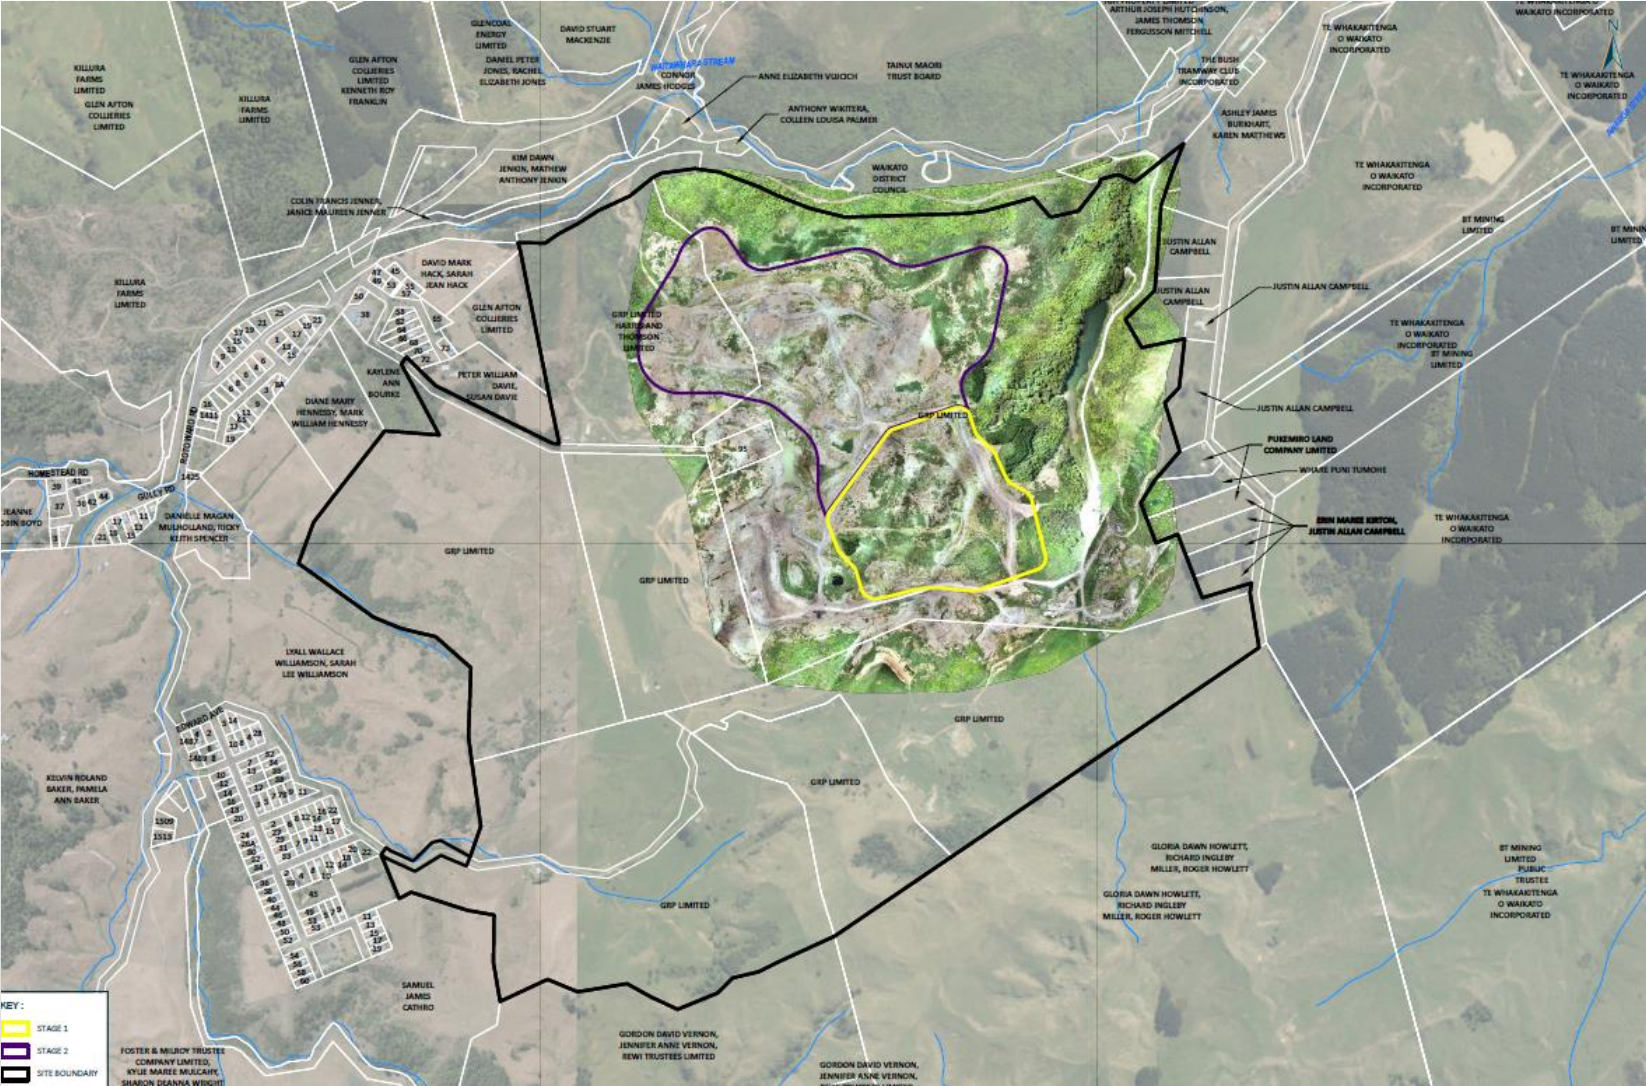
New Stages 1 and 2

- Stage 1 – 2 landfill boundaries will cover the disturbed area of the site.
- Stage 1 of the C&D landfill is expected to be operational and filled in approximately 15 years.
- Stage 2 is the larger stage, and it is expected to accommodate C&D waste for around a further 10 - 25 years.
- The total landfill airspace for Stages 1 and 2 is currently estimated to be around 14 Mm³.
- To provide sufficient airspace for approximately 1 years of waste acceptance (up to 208,000 tonnes, as per consent AUTH138113.04.02 Discharge Permit Land – Solid Waste).
- Table 1 summarises the total earthworks volumes and the airspace volumes for Stage 1 (around 4 Mm³) and Stage 2 (around 10 Mm³). These volumes are subject to the final design of the base contours for the two stages.

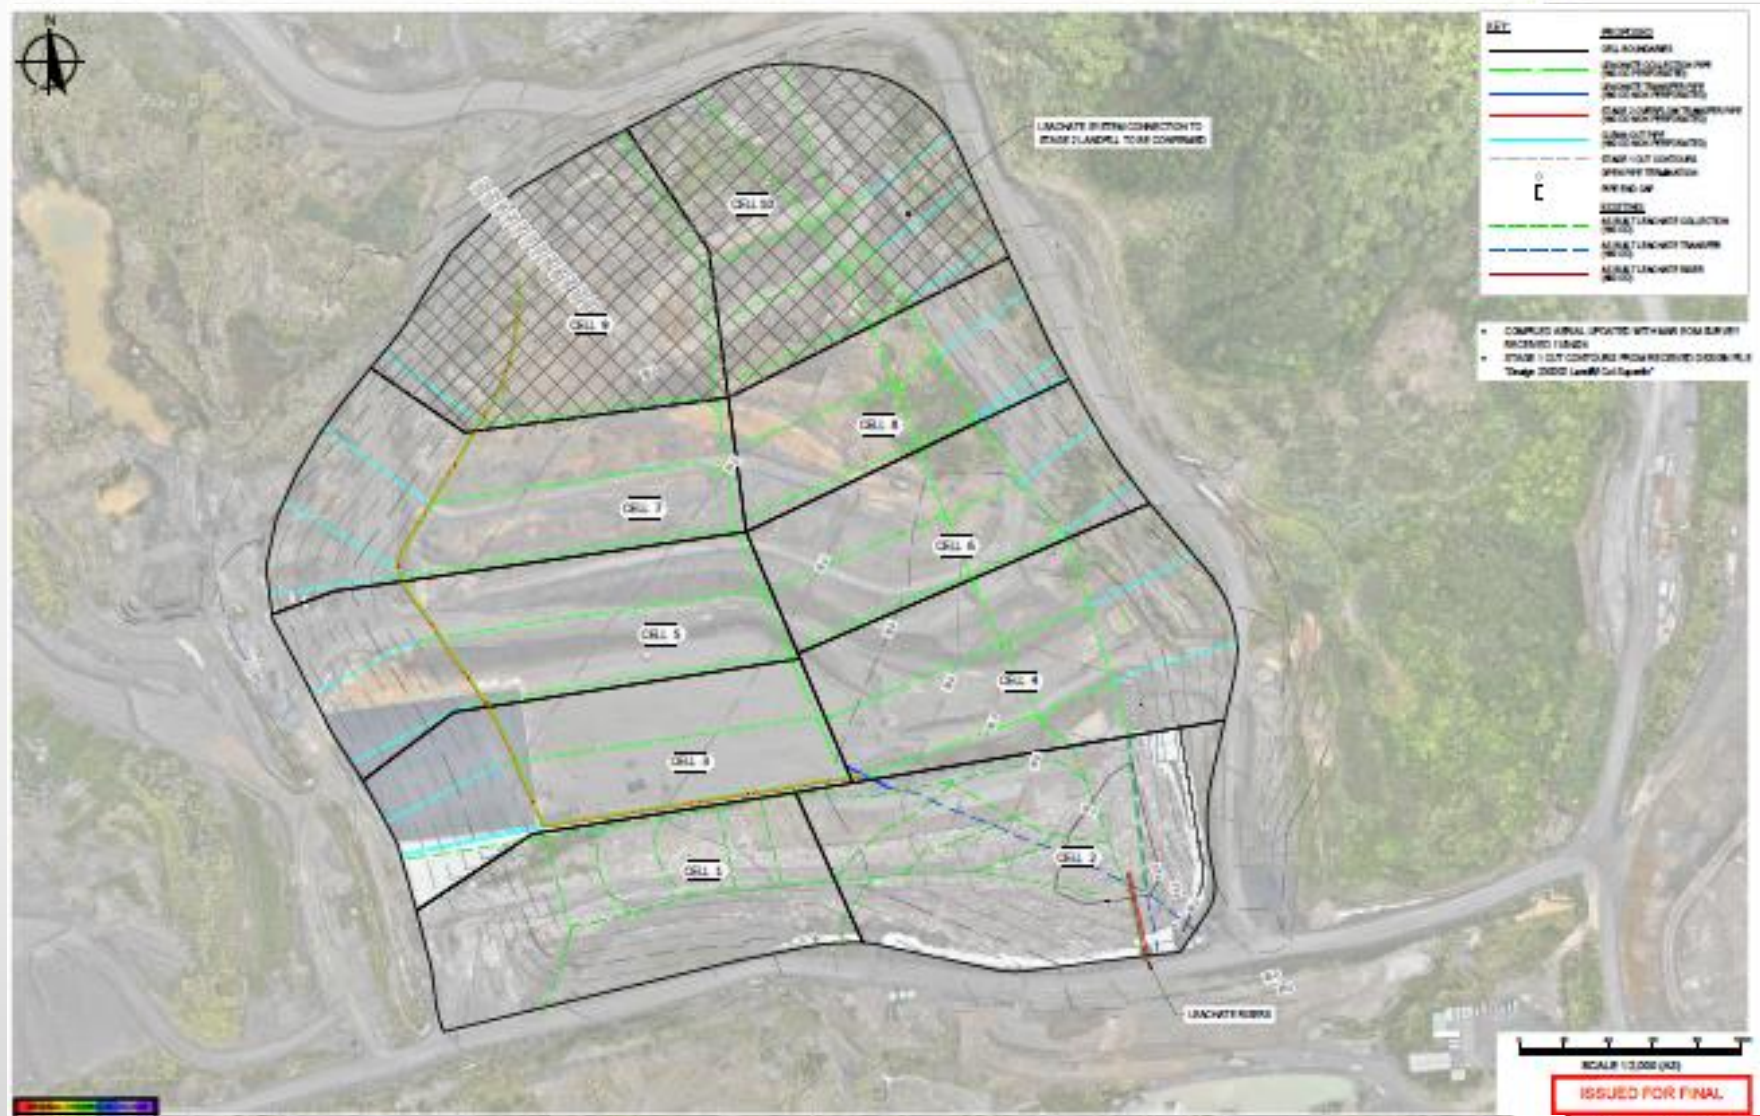
Stage 1 – Cells and Leachate Collection

- 1.5 mm thick HDPE geomembrane.
- Geomembrane smooth both sides on base of Cell 2 and textured both sides on side slopes (see below).
- 5 mm thick GCL ($k < 5 \times 10^{-11}$ m/s), extending at least 1 m up the cell side above finished floor levels (see board for leachate levels).
- 300 mm thick CCL ($k < 10^{-8}$ m/s) compacted in layers ≤ 150 mm thick on the floor.

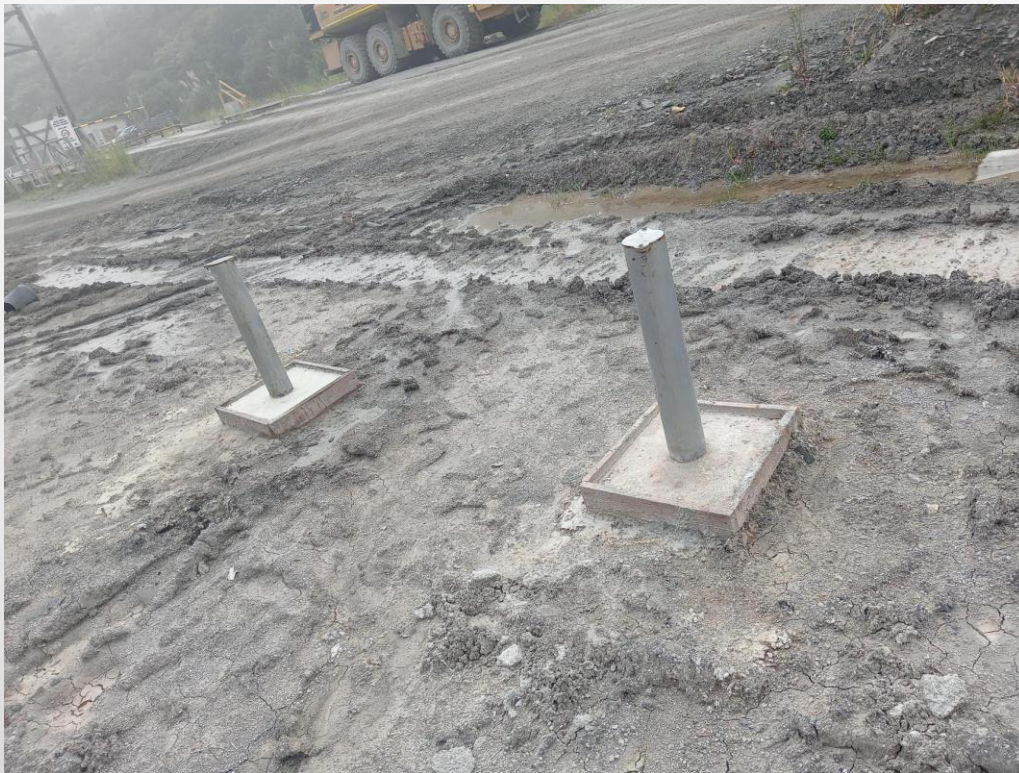
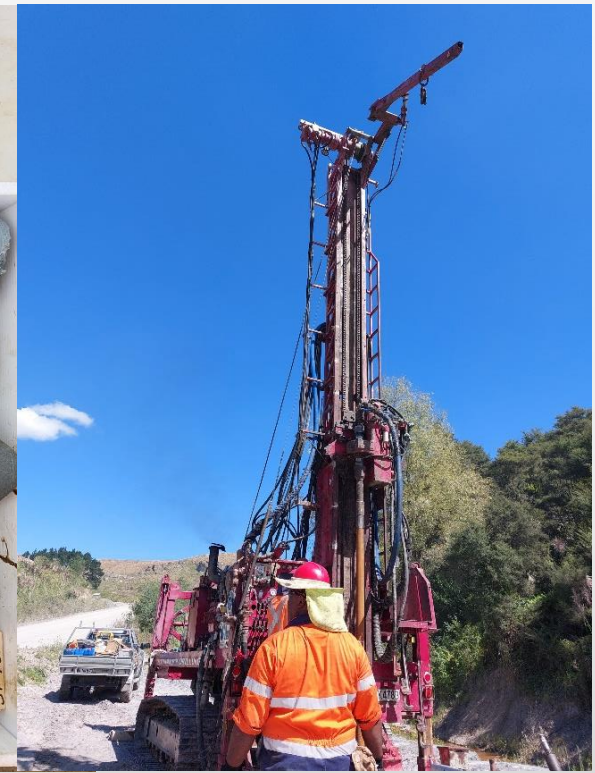
Borehole Drilling

- Core geological logging of 5 No. boreholes to maximum depth of 92.5 m.
- Groundwater and geotechnical testing / laboratory testing.
- Groundwater level monitoring of deep and shallow groundwater levels.

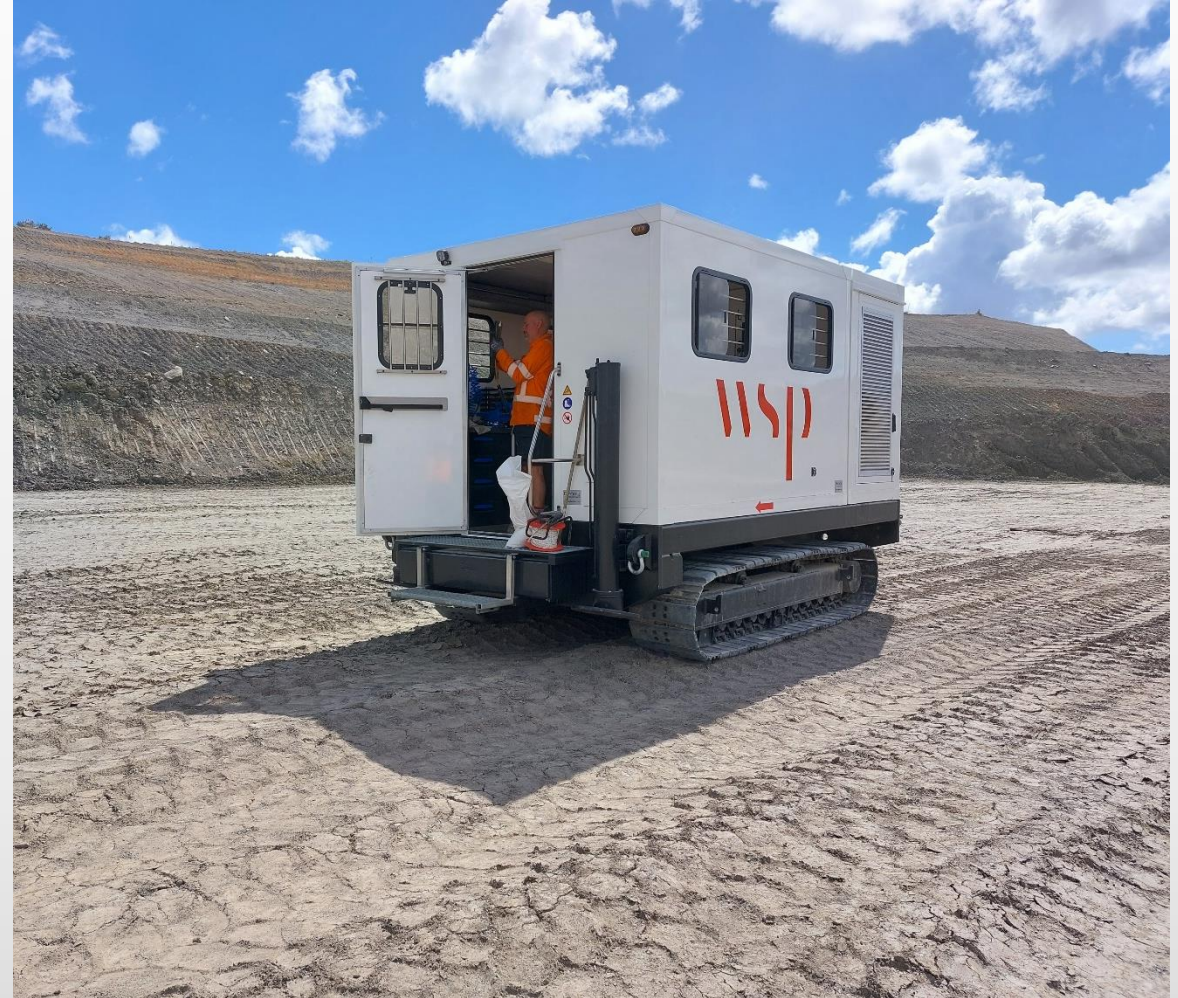
Cone Penetration Tests

- Determine ground conditions under the cell.
 - Density of reworked overburden fill
 - Locate the top of the in-situ rock
 - Correlate with existing geological model
- Cell 13 No. CPTs to depth range 5 – 17 m bgl to coal floor.
- WSP and Brown Bros.

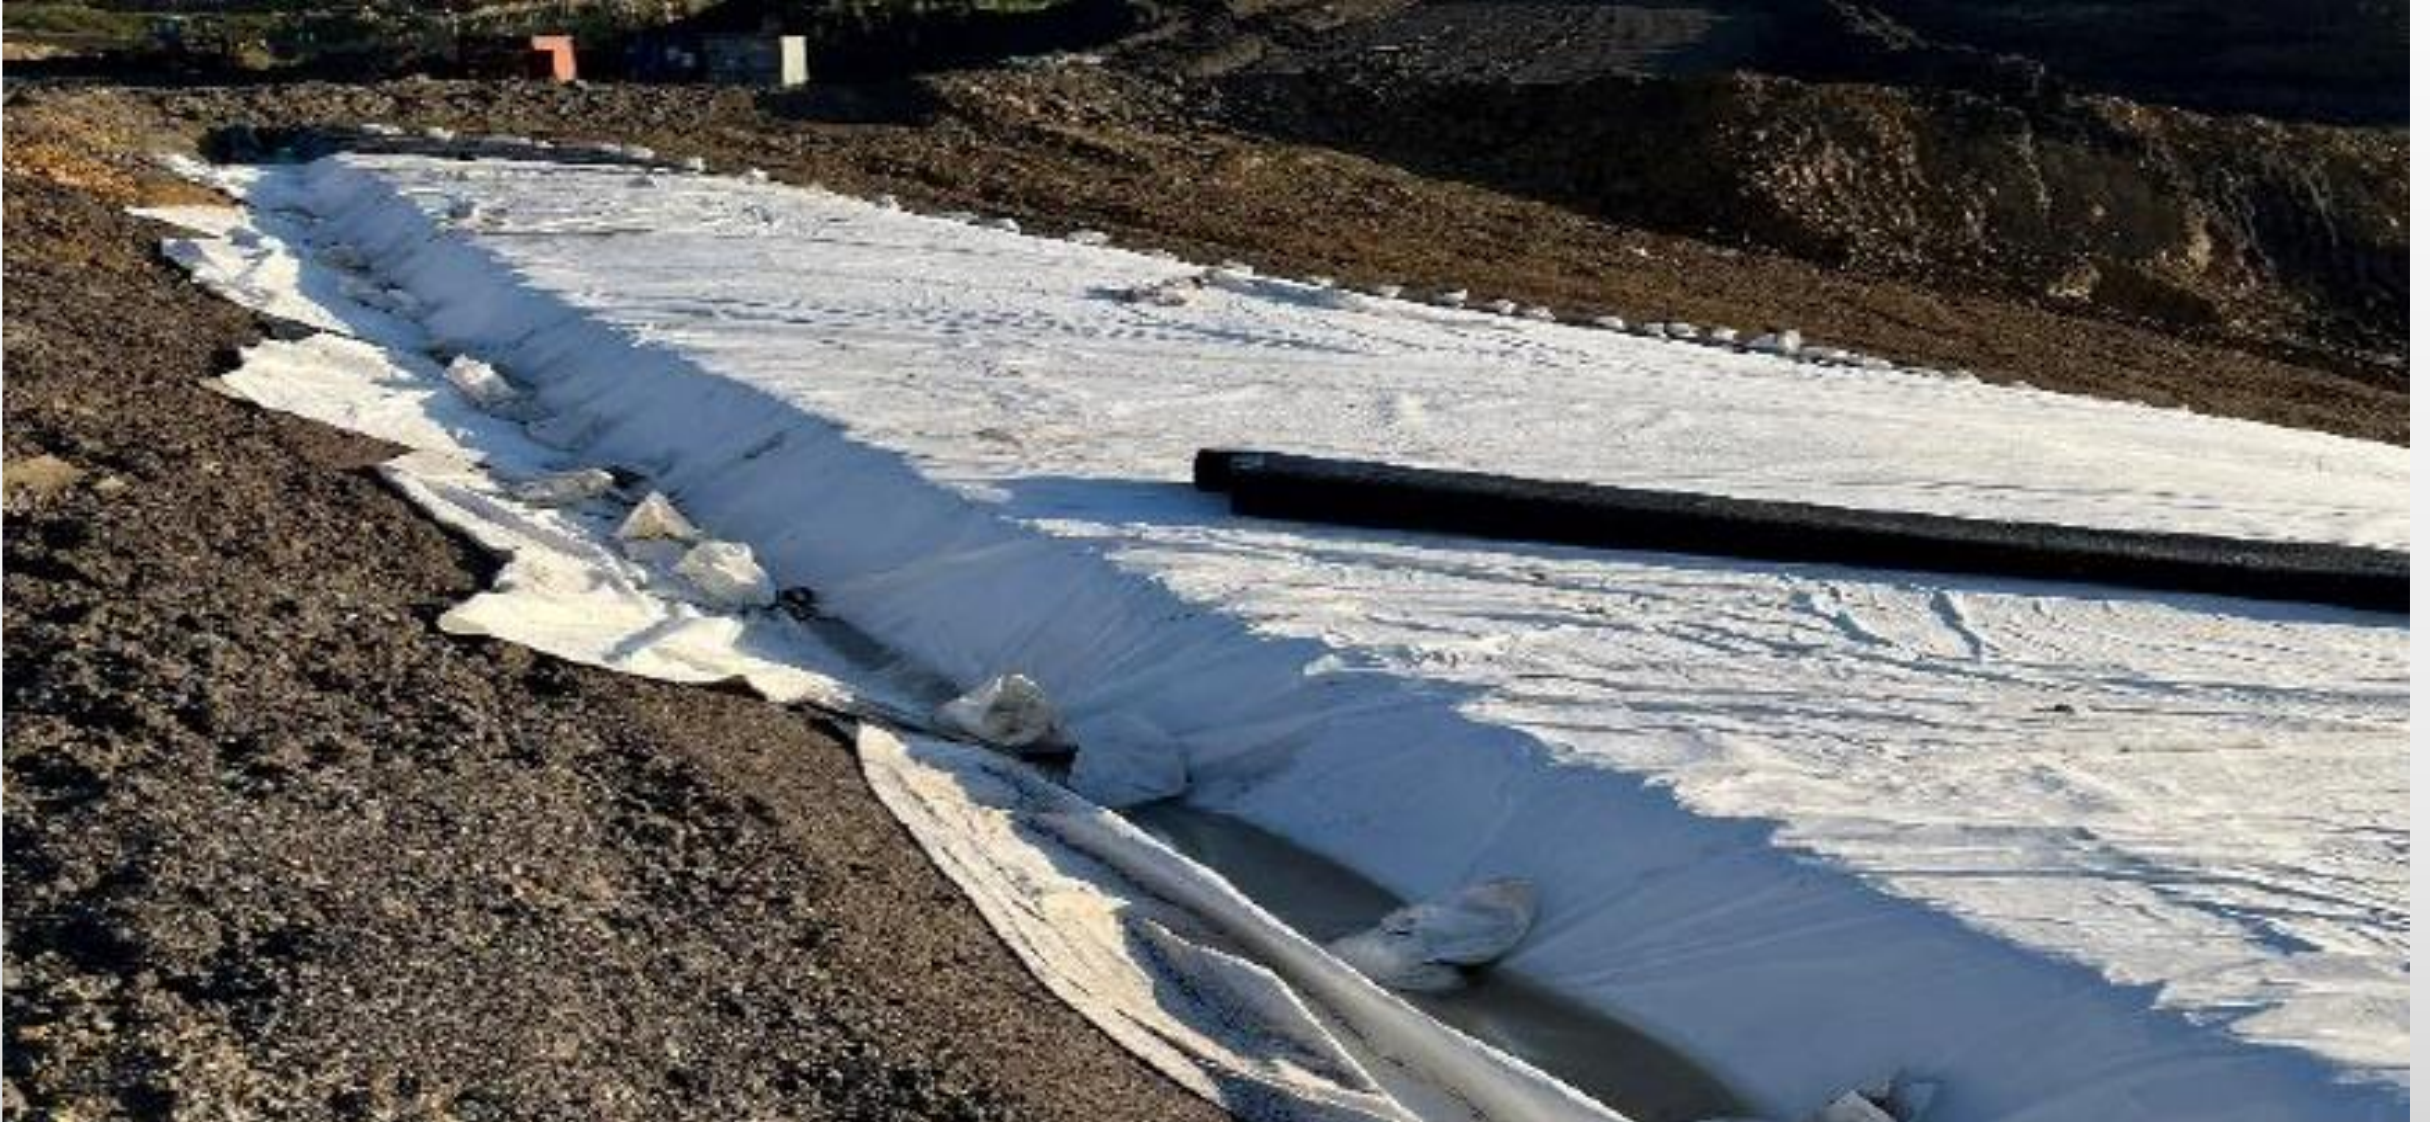
Construction Phase

Earthworks, Investigate, Sub-soil Drainage, Cell Preparation, Lining

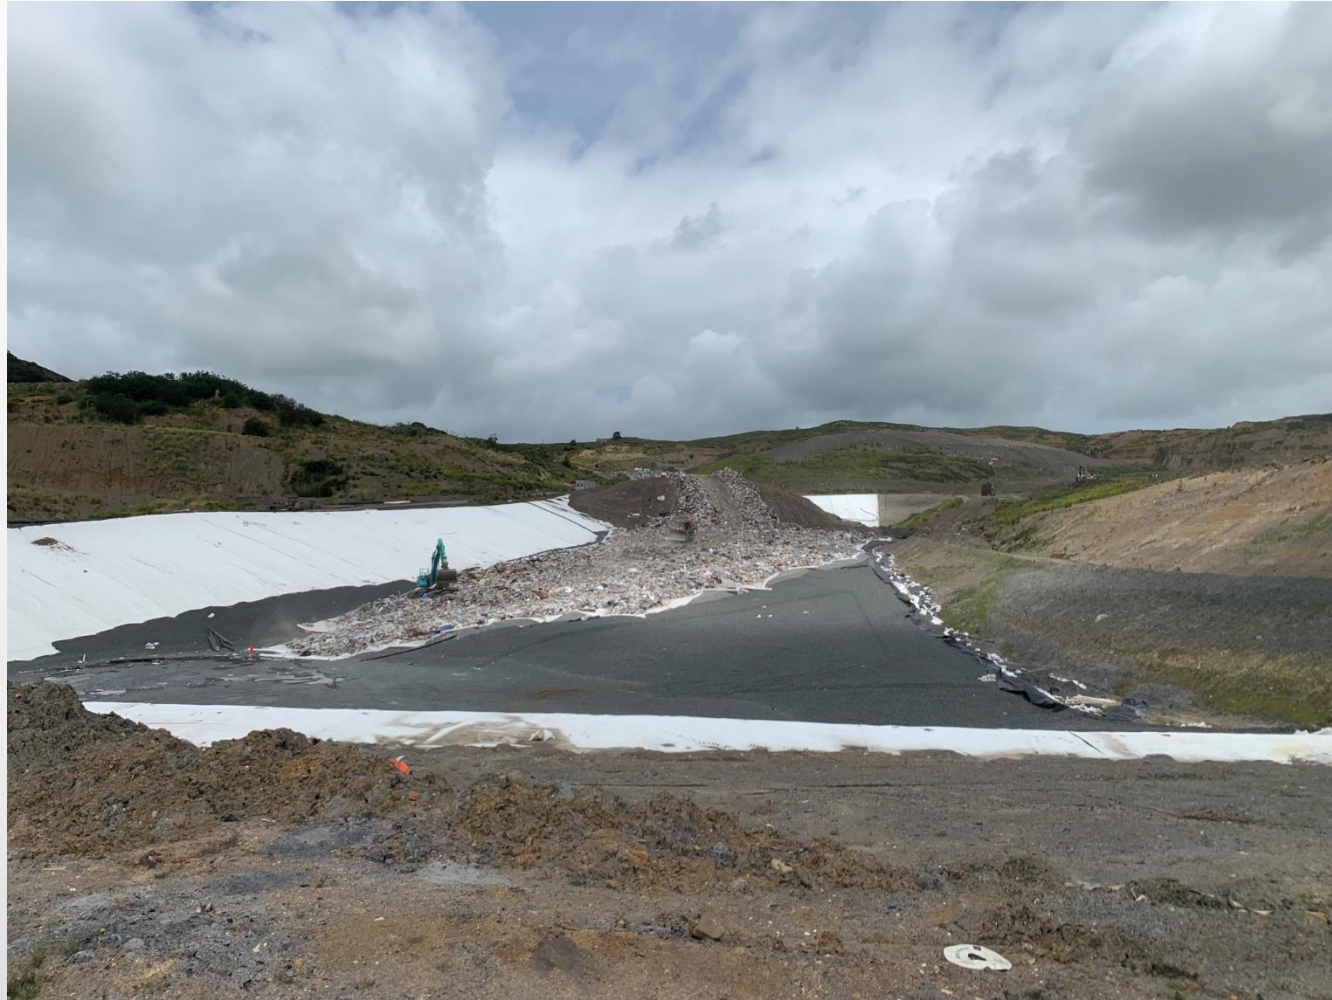
Landfill Phase

Filling process, Intermediate Capping, Leachate Management
